Rumford River Monitoring Project

Norton, MA

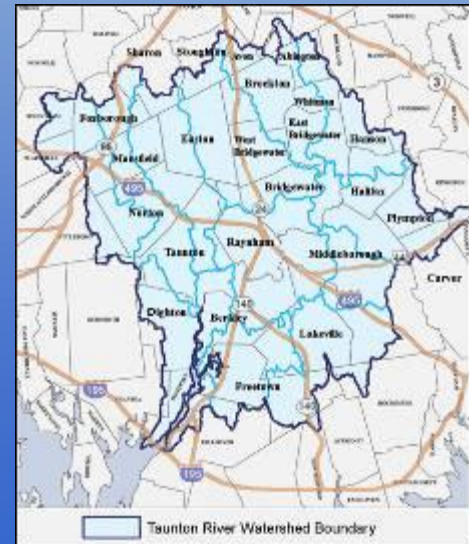
A Watershed

- A watershed is an area of land that drains to one point. Also it can be an area where precipitation falls and is caught and drained into rivers, marshes, or streams.

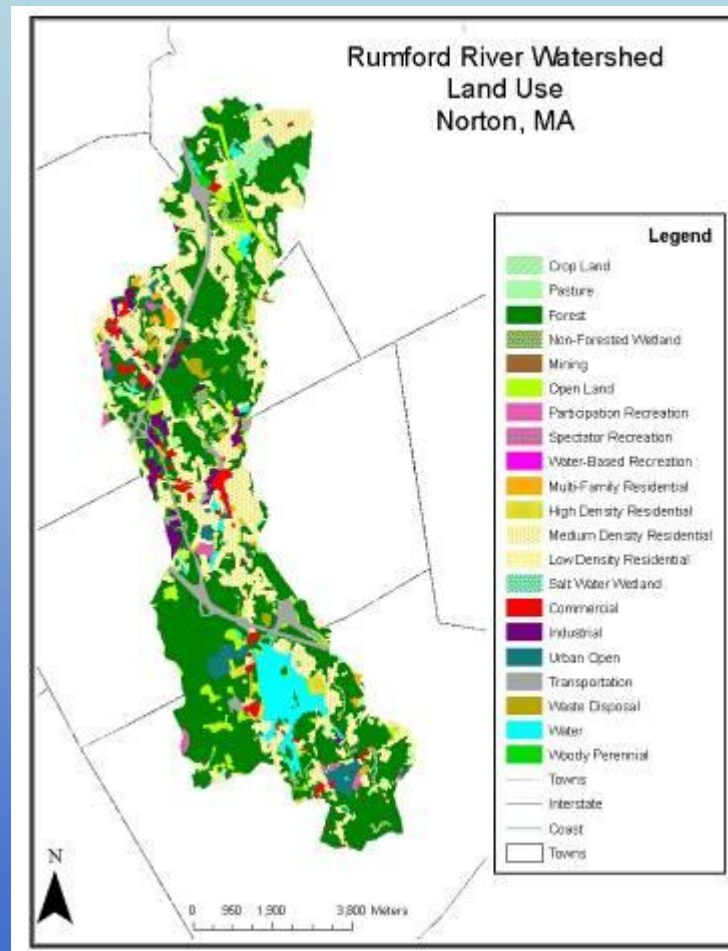
Land Use Map

- Land surrounding the Norton Reservoir is highly developed with residential housing
- Most housing developments use septic systems for waste treatment.
- Three major road systems are located in a close proximity to the Norton Reservoir and the Rumford River: Route 495, Route 123, and Route 140.
